SERVICE BULLETIN

TITLE: LANDING GEAR - REPLACEMENT OF NOSE GEAR TRUNNION CHAMFERED WASHERS

Beech Model A36 Bonanza, Serials E-3565 through E-3587, E-3590, E-3592, E-3593, E-3594, E-3598, E-3599, E-3601, E-3602, E-3604, E-3607 and E-3611 through E-3642.

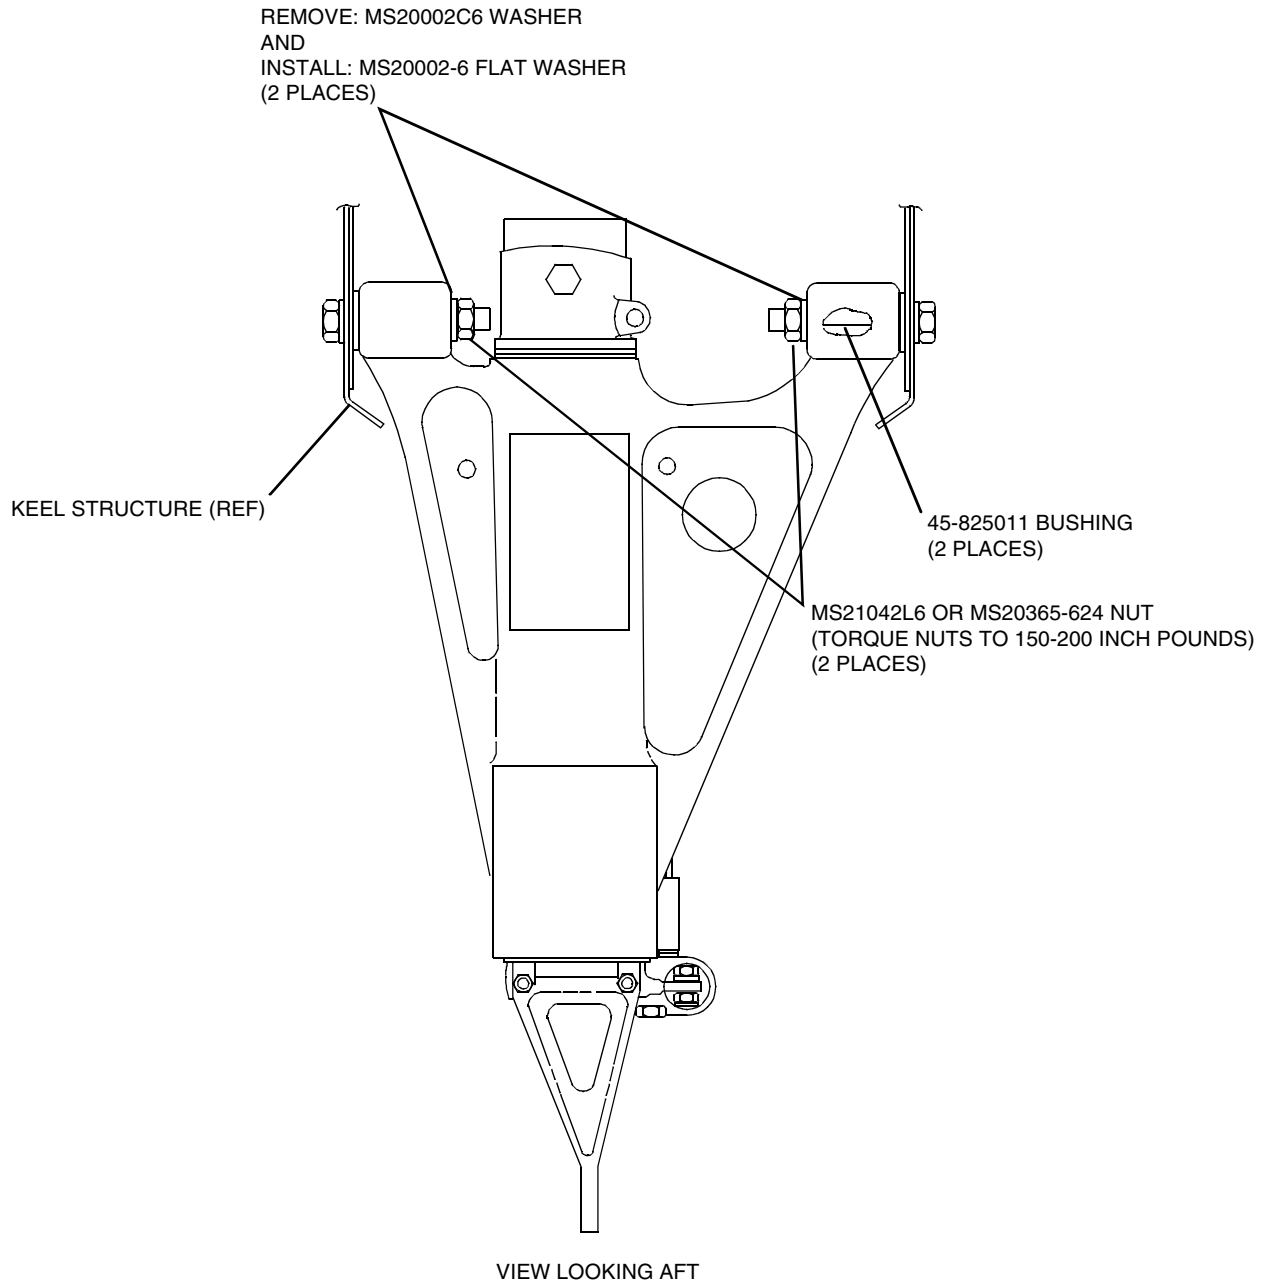
Figure 1
Nose Gear Trunnion Hardware Location

This Service Bulletin is being issued because Raytheon Aircraft Company (RAC) has received reports of landing gear trunnion nuts not maintaining proper torque when the chamfered washer was not properly installed.

- (3) Remove and discard the P/N MS21042L6 or MS20365-624 nut from the nose gear trunnion and inspect the P/N MS20002C6 chamfered washer to see if the countersunk side is facing toward the nut. Refer to Figure 1 for the locations of nose gear trunnion hardware.

- (a) If the countersunk side of the washer is facing toward the nut, replace with P/N MS20002-6 flat washer. Install new P/N MS21042L6 or MS20365-624 nut and torque to 150 - 200 in. lbs.

- (b) If the countersunk side of the washer is not facing toward the nut, replace P/N 45-825011 bushing with new bushing in accordance with Bonanza Series Maintenance Manual, Chapter 32. Install P/N MS20002-6 flat washer. Install new P/N MS21042L6 or MS20365-624 nut and torque to 150 - 200 in. lbs.
