**[Docket No. 2000-CE-44-AD; Amendment 39-12920; AD 2002-21-13]**

### **Airworthiness Directives; Raytheon Aircraft Company Beech Models 35, 35R, A35, and B35 Airplanes**

**ACTION:** Final rule.

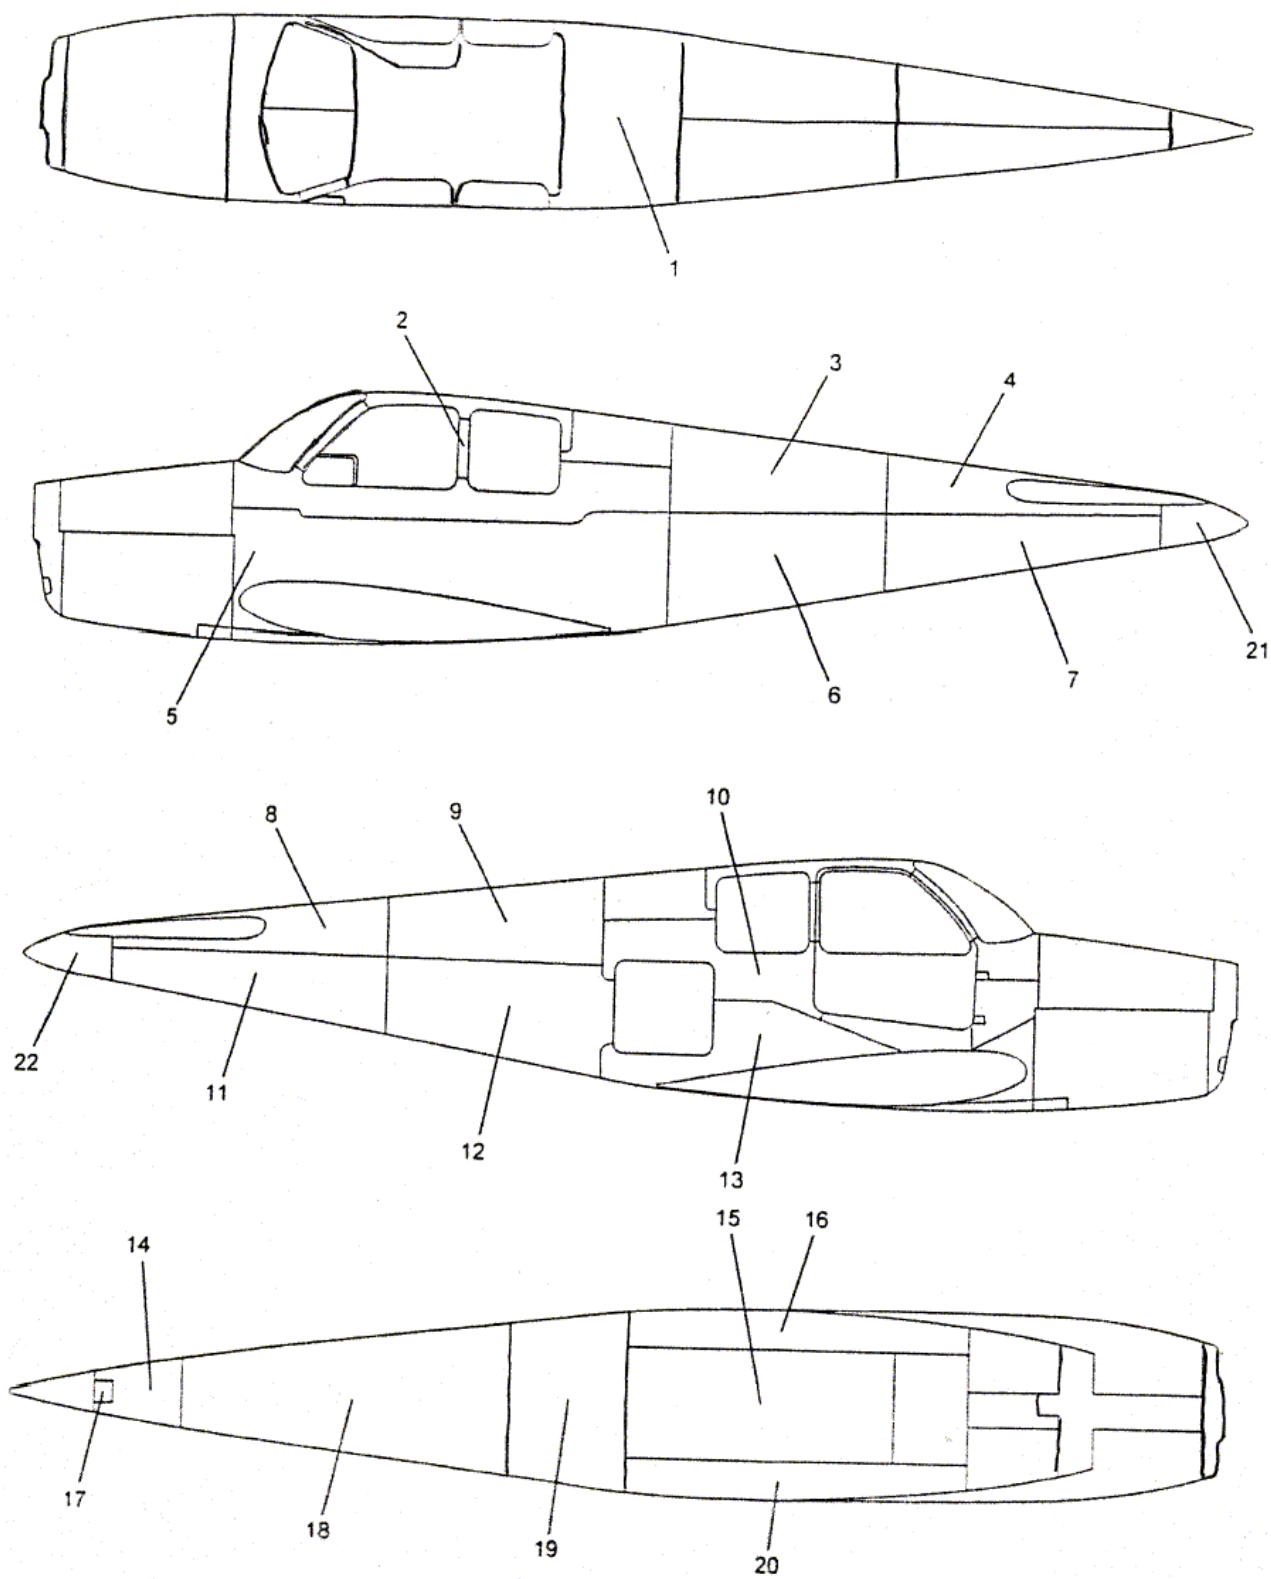
**Figure 1**

(5) Visually inspect the empennage, aft fuselage, and ruddervator control system for damage: (i) Part of this is an inspection of the aft fuselage skin for wrinkles or cracks. Specific skin thicknesses are presented in Figures 1 and 2 of this AD. The skin thickness measurement is not repetitive. (ii) The inspection and setting of the travels on the elevator and elevator trim tabs are not repetitive. (iii) Repair or replace any damaged parts and set the elevator controls, rudder and tab system controls, cable tensions, and rigging.	Inspect within the next 100 hours TIS after the last inspection required by AD 94-20-04 or within the next 25 hours TIS after December 10, 2002 (the effective date of this AD), whichever occurs later, and thereafter at intervals not to exceed 100 hours TIS, except for the skin thickness measurement and the inspection and setting of the travels on the elevator and elevator trim tabs, which are one-time actions. Accomplish any repairs, replacements, and adjustments prior to further flight after the applicable inspection.	Accomplish the inspection and repairs or replacements in accordance with the procedures in paragraphs (5)(a) through (5)(f) of the ACCOMPLISHMENT INSTRUCTIONS section of Raytheon Service Bulletin No. SB 27-3358, Issued: February, 2000, and use a digital ultrasonic skin tester or equivalent skin tester or direct methods that utilize calipers and micrometers. Specific skin thicknesses are contained in Figures 1 and 2 of this AD.

**Skin Thickness - Raytheon Aircraft (Beech) Models 35, 35R, A35, and B35**
